**Flood Control Project Maintenance
Levee Inspections**
LMA District Cover Sheet
Spring 2017 Levee Inspection Results

Madera County FCWCA

**Flood Control Project Maintenance
Levee Inspections
Unit Cover Sheet
Spring 2017 Levee Inspection Results
Madera County FCWCA**

Waterway			Bank	Unit Miles
Unit No. 01 Ash Slough			Right	2.37
	Spring (March - May)	Summer (June - August)	(September - November) Fall	Winter (December - February)
Unit Maintenance Rating (Fall Only)				
Date of Inspection	5/4/2017 - 5/4/2017			
DWR Inspector	Herman Phillips			
Accompanied By

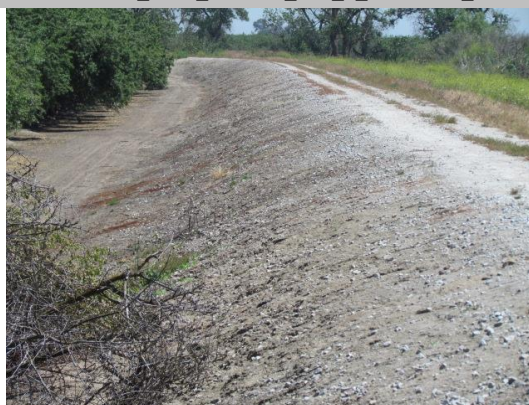
Photo 1 of 1 : SP_2017_NA0011_142_9_20170508_00021.jpg

LM Start	0.03	Rating **	A	Issue No.	9
LM End	0.25	Issue Type +	Ma	Location *	LS
Category	Earthen Levee			GPS Latitude/Longitude	
				Start	End
Item	Vegetation			37.046608 °	37.047553 °
				-120.427455 °	-120.423673 °
DWR ID	DWR_NA0011_01_s_2017_9				
Comment Code					
V1 : Control annual grass and weeds on the levee slopes and easements.					
Inspector Comment					
There is no unwanted vegetation at the levee miles listed along the landside slope.

Looking upstream from levee mile 0.03-0.25 there is no unwanted vegetation.

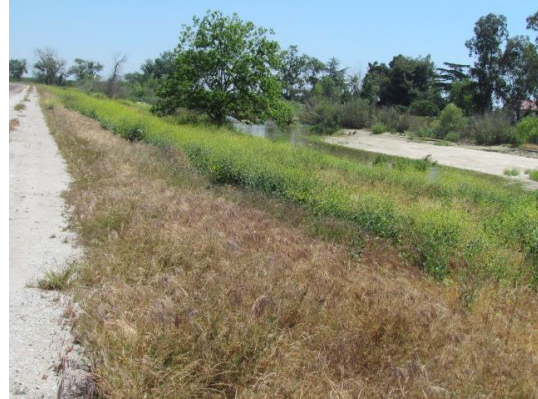
Photo 1 of 1 : SP_2017_NA0011_142_15_20170508_00022.jpg

LM Start	0.03	Rating **	U	Issue No.	15
LM End	2.31	Issue Type +	Ma	Location *	WS
Category	Earthen Levee			GPS Latitude/Longitude	
				Start	End
Item	Vegetation			37.046608 °	37.067958 °
				-120.427455 °	-120.398828 °
DWR ID	DWR_NA0011_01_s_2017_15				
Comment Code					
V2 : Remove the wild growth other than native grasses from the levee slopes.					
Inspector Comment					
Remove the unwanted tall weeds present on the waterside levee slope.

Looking upstream from the levee mile 0.03-2.31 tall unwanted weeds present on the waterside slope.

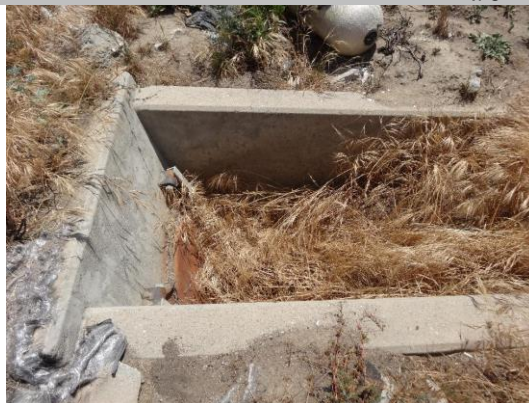
Photo 2 of 3 : UCIP_SP_2017_49976_69673.jpg

LM Start	0.04	Rating **	U	Issue No.	45 (cont)
LM End	0.04	Issue Type +	En	Location *	WS

Flap gate located on WS blocked by dense vegetation.

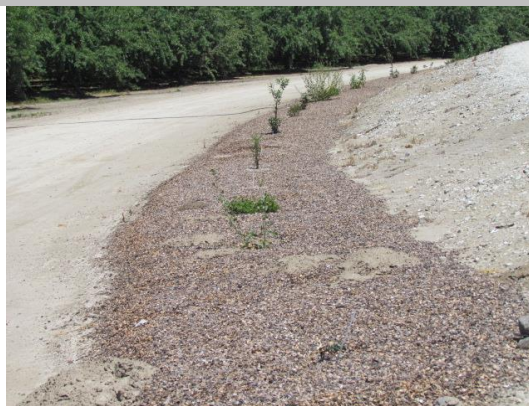
Photo 1 of 3 : SP_2017_NA0011_142_28_20170508_00027.jpg

LM Start	0.89	Rating **	U	Issue No.	28
LM End	1.15	Issue Type +	En	Location *	LS
Category	Earthen Levee			GPS Latitude/Longitude	
				Start	End
Item	Encroachments			37.054797 °	37.056328 °
				-120.416897 °	-120.412685 °
DWR ID	DWR_NA0011_01_s_2017_28				
Comment Code					
LI : Landscape Irrigation					
Inspector Comment					
This landscape has not been authorized.

Looking upstream from levee mile 0.89 to levee mile 1.15. Unauthorized landscaping on the landward toe.

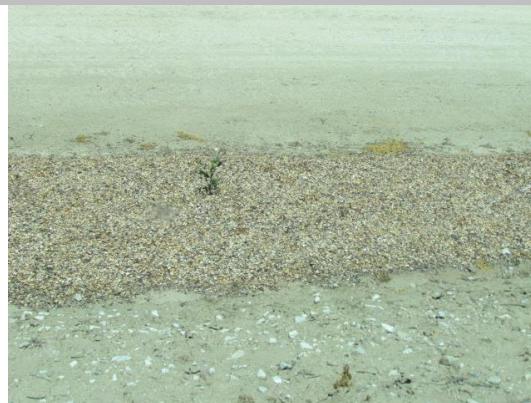
Photo 3 of 3 : SP_2017_NA0011_142_28_20170508_00029.jpg

LM Start	0.89	Rating **	U	Issue No.	28 (cont)	
LM End	1.15	Issue Type +	En	Location *	LS	
Category	Earthen Levee			GPS Latitude/Longitude		
				Start		End
Item	Encroachments			37.054797 °		37.056328 °
				-120.416897 °		-120.412685 °
DWR ID	DWR_NA0011_01_s_2017_28					
Comment Code						
LI : Landscape Irrigation						
Inspector Comment						
This landscape has not been authorized.

Unauthorized landscaping on the landward continues.

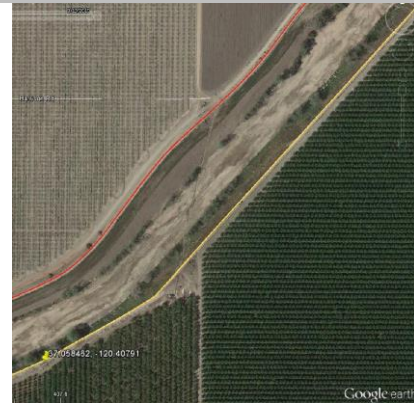
Photo 1 of 3 : UCIP_SP_2017_50057_75206.jpg

FS_ID:50057
DS_ID:25456
EP_NO: N/A
Repair Type: Urgent
Crossing Status: Found
UCIP Comments: 7/14/2016 Open pipe still remains on WS through short levee. Need to contact owner to determine extent of work completed through section of levee. (DWR UCIP - omagana)6/14/2016 Levee disturbed without prior authorization, it appears that the pipe owner did not notify CVFPB of the construction activity. Crossing was added to UCIP database. Spoke to Herman Phillips (DWR Levee Inspector) regarding unauthorized pipe installation along LS toe of U2. The LS toe of U2 (approximately 731 feet) was disturbed. DWR Inspector mentioned that Dario Dominguez with Madera County Flood Control, LMA representative, has sent the pipe owner notification of unauthorized excavation to replace existing pipe along U2 LS toe, dated May 5, 2016. After reviewing the timed aerial photographs (aerials) under Google Earth a new discovery was made regarding the extend of the area disturbed. Based on the aerials it appears that the new pipe system goes through U1 and U2 levees, across Ash Slough, and along LS toe of U2. The pipe through the levees and channel appears to tie into the work currently being done on the LS toe of U2. Both U1 and U2 levees appear to have been disturbed during 2014-2015. The aerials show that the crossing was not present in the aerial dated 4/5/2014, crossing was not present during the 2014 UCIP Inspection dated 5/6/2014, and the crossing was present in the aerial dated 3/18/2015. According to DWR Inspector, Dario Dominguez with Madera County Flood Control was notified of the additional unauthorized encroachment issue (unauthorized work completed in 2014-2015 on both levees and the channel) that could be related to the trench work being completed by Mr. Sterling. (DWR UCIP - omagana) FIELD_STRUCT_DESC: "ILLEGAL ENCROACHMENT" 10-inch to 12-inch irrigation pipe of unknown material through the levee, at an unknown depth below the crown. Pipe goes through both levees and across channel. The pipe starts on landside (LS) toe of Unit 1 (U1) and continues across channel and through Unit 2 (U2), the pipe then runs along the landside toe of U2 for approximately 731 feet. Owner of this crossing has been identified as Mr. Michael Alexander Sterling, 19140 Faralton Road, Madera, CA 93638-0313.

Aerial photo of Encroachment visible through levee and channel in 2015.
(Source: Google Earth, 3/18/2015)

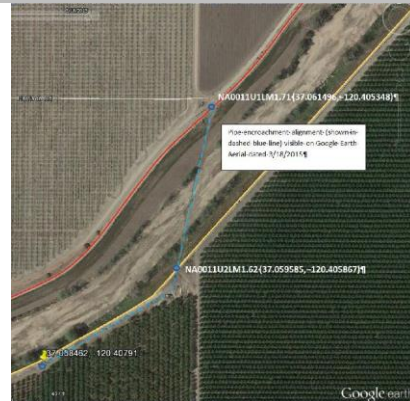
Photo 2 of 3 : UCIP_SP_2017_50057_75221.jpg

FS_ID:50057
DS_ID:25456
EP_NO: N/A
Repair Type: Urgent
Crossing Status: Found
UCIP Comments: 7/14/2016 Open pipe still remains on WS through short levee. Need to contact owner to determine extent of work completed through section of levee. (DWR UCIP - omagana)6/14/2016 Levee disturbed without prior authorization, it appears that the pipe owner did not notify CVFPB of the construction activity. Crossing was added to UCIP database. Spoke to Herman Phillips (DWR Levee Inspector) regarding unauthorized pipe installation along LS toe of U2. The LS toe of U2 (approximately 731 feet) was disturbed. DWR Inspector mentioned that Dario Dominguez with Madera County Flood Control, LMA representative, has sent the pipe owner notification of unauthorized excavation to replace existing pipe along U2 LS toe, dated May 5, 2016. After reviewing the timed aerial photographs (aerials) under Google Earth a new discovery was made regarding the extend of the area disturbed. Based on the aerials it appears that the new pipe system goes through U1 and U2 levees, across Ash Slough, and along LS toe of U2. The pipe through the levees and channel appears to tie into the work currently being done on the LS toe of U2. Both U1 and U2 levees appear to have been disturbed during 2014-2015. The aerials show that the crossing was not present in the aerial dated 4/5/2014, crossing was not present during the 2014 UCIP Inspection dated 5/6/2014, and the crossing was present in the aerial dated 3/18/2015. According to DWR Inspector, Dario Dominguez with Madera County Flood Control was notified of the additional unauthorized encroachment issue (unauthorized work completed in 2014-2015 on both levees and the channel) that could be related to the trench work being completed by Mr. Sterling. (DWR UCIP - omagana) FIELD_STRUCT_DESC: "ILLEGAL ENCROACHMENT" 10-inch to 12-inch irrigation pipe of unknown material through the levee, at an unknown depth below the crown. Pipe goes through both levees and across channel. The pipe starts on landside (LS) toe of Unit 1 (U1) and continues across channel and through Unit 2 (U2), the pipe then runs along the landside toe of U2 for approximately 731 feet. Owner of this crossing has been identified as Mr. Michael Alexander Sterling, 19140 Faralton Road, Madera, CA 93638-0313.

Assumed alignment of pipe through the levees and along LS toe of U2.
(Source: Google Earth, 3/18/2015)

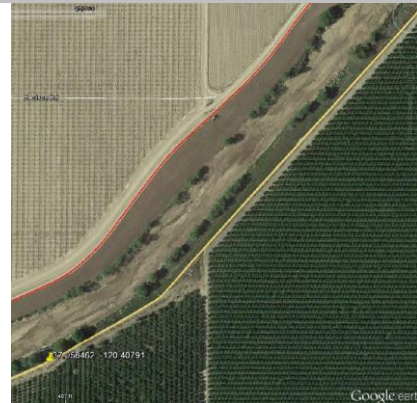
Photo 3 of 3 : UCIP_SP_2017_50057_75207.jpg

FS_ID:50057
DS_ID:25456
EP_NO: N/A
Repair Type: Urgent
Crossing Status: Found
UCIP Comments: 7/14/2016 Open pipe still remains on WS through short levee. Need to contact owner to determine extent of work completed through section of levee. (DWR UCIP - omagana)6/14/2016 Levee disturbed without prior authorization, it appears that the pipe owner did not notify CVFPB of the construction activity. Crossing was added to UCIP database. Spoke to Herman Phillips (DWR Levee Inspector) regarding unauthorized pipe installation along LS toe of U2. The LS toe of U2 (approximately 731 feet) was disturbed. DWR Inspector mentioned that Dario Dominguez with Madera County Flood Control, LMA representative, has sent the pipe owner notification of unauthorized excavation to replace existing pipe along U2 LS toe, dated May 5, 2016. After reviewing the timed aerial photographs (aerials) under Google Earth a new discovery was made regarding the extend of the area disturbed. Based on the aerials it appears that the new pipe system goes through U1 and U2 levees, across Ash Slough, and along LS toe of U2. The pipe through the levees and channel appears to tie into the work currently being done on the LS toe of U2. Both U1 and U2 levees appear to have been disturbed during 2014-2015. The aerials show that the crossing was not present in the aerial dated 4/5/2014, crossing was not present during the 2014 UCIP Inspection dated 5/6/2014, and the crossing was present in the aerial dated 3/18/2015. According to DWR Inspector, Dario Dominguez with Madera County Flood Control was notified of the additional unauthorized encroachment issue (unauthorized work completed in 2014-2015 on both levees and the channel) that could be related to the trench work being completed by Mr. Sterling. (DWR UCIP - omagana) FIELD_STRUCT_DESC: "ILLEGAL ENCROACHMENT" 10-inch to 12-inch irrigation pipe of unknown material through the levee, at an unknown depth below the crown. Pipe goes through both levees and across channel. The pipe starts on landside (LS) toe of Unit 1 (U1) and continues across channel and through Unit 2 (U2), the pipe then runs along the landside toe of U2 for approximately 731 feet. Owner of this crossing has been identified as Mr. Michael Alexander Sterling, 19140 Faralton Road, Madera, CA 93638-0313.

Aerial photo of Encroachment not present in 2014. (Source: Google Earth, 4/5/2014)

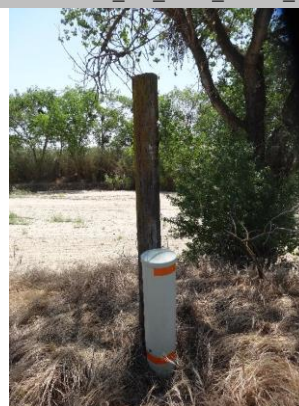
Photo 1 of 1 : UCIP_SP_2017_39846_71806.jpg

LM Start	2.09	Rating **	M	Issue No.	47
LM End	2.09	Issue Type +	En	Location *	WS
Category	Supplemental			GPS Latitude/Longitude	
				Start	End
Item	DWR UCIP Field Study			37.065569 °	37.065569 °
				-120.400752 °	-120.400752 °
DWR ID					
Comment Code					
Inspector Comment					
FS_ID:39846 DS_ID:21511 EP_NO: N/A Repair Type: Non-Urgent Crossing Status: Indicator Found UCIP Comments: Need to contact to owner to get contact information. FIELD_STRUCT_DESC: Underground telephone cable crosses through levee. FS Date: 5/6/2014

Conduit box located on waterward side.

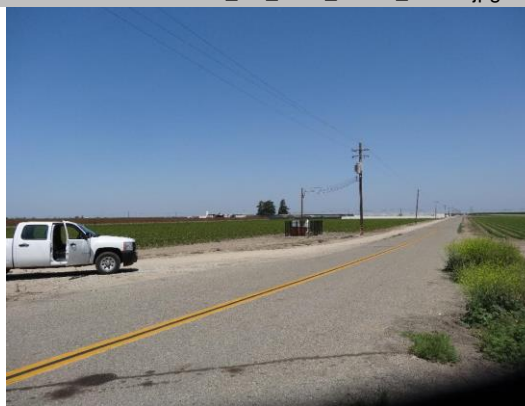
Photo 1 of 3 : UCIP_SP_2017_39845_71800.jpg

LM Start	2.10	Rating **	M	Issue No.	48
LM End	2.10	Issue Type +	En	Location *	WS
Category	Supplemental			GPS Latitude/Longitude	
				Start	End
Item	DWR UCIP Field Study			37.065649 °	37.065649 °
				-120.400663 °	-120.400663 °
DWR ID					
Comment Code					
Inspector Comment					
FS_ID:39845					
DS_ID:25042					
EP_NO: N/A					
Repair Type: Non-Urgent					
Crossing Status: Found					
UCIP Comments: Need to contact owner to determine if crossing goes through levee.					
FIELD_STRUCT_DESC: 10-inch or 12-inch pipe through levee crossing visible inside concrete standpipe on waterward side. Potential pump station located on landward side approximately 100 feet from standpipe.					
FS Date: 5/6/2014

Pump station visible approximately 100 feet from concrete standpipe.

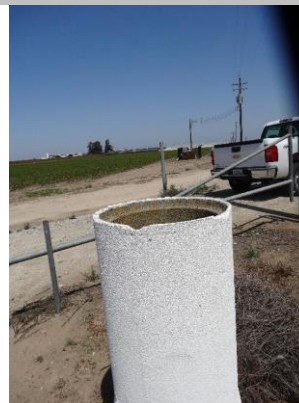
Photo 2 of 3 : UCIP_SP_2017_39845_71803.jpg

LM Start	2.10	Rating **	M	Issue No.	48 (cont)
LM End	2.10	Issue Type +	En	Location *	WS
Category	Supplemental			GPS Latitude/Longitude	
				Start	End
Item	DWR UCIP Field Study			37.065649 °	37.065649 °
				-120.400663 °	-120.400663 °
DWR ID					
Comment Code					
Inspector Comment					
FS_ID:39845 DS_ID:25042 EP_NO: N/A Repair Type: Non-Urgent Crossing Status: Found UCIP Comments: Need to contact owner to determine if crossing goes through levee. FIELD_STRUCT_DESC: 10-inch or 12-inch pipe through levee crossing visible inside concrete standpipe on waterward side. Potential pump station located on landward side approximately 100 feet from standpipe. FS Date: 5/6/2014

Standpipe visible on waterward side.

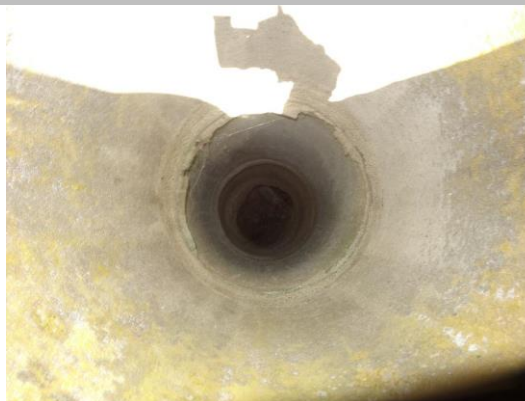
Photo 3 of 3 : UCIP_SP_2017_39845_71804.jpg

LM Start	2.10	Rating **	M	Issue No.	48 (cont)
LM End	2.10	Issue Type +	En	Location *	WS

Inside view of concrete standpipe.

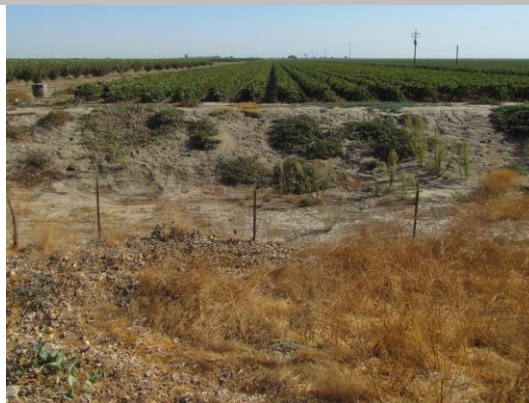
Photo 1 of 1 : SP_2017_NA0011_143_32_20170404_00016.jpg

LM Start	0.00	Rating **	U	Issue No.	32
LM End	0.00	Issue Type +	En	Location *	LS
Category	Earthen Levee			GPS Latitude/Longitude	
				Start	End
Item	Encroachments			37.045539 °	37.045505 °
				-120.427444 °	-120.427473 °
DWR ID	DWR_NA0011_02_f_2012_32				
Comment Code					
DT : Ditch					
Inspector Comment					
There is a settling basin on the landward side of the levee. This basin is very close to the landside easement.

Ash Slough at levee mile 0.01- 0.03. Settling basin on the landside levee berm.

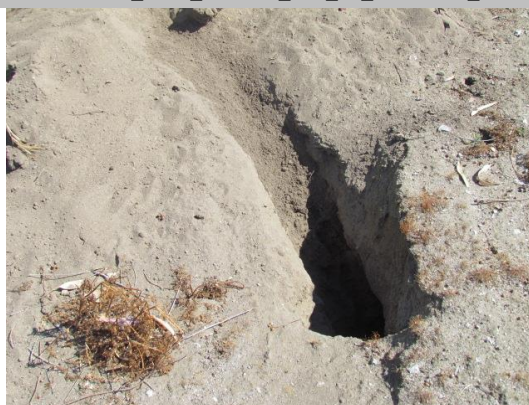
Photo 1 of 2 : SP_2017_NA0011_143_39_20170508_00038.jpg

LM Start	0.00	Rating **	U	Issue No.	39
LM End	1.67	Issue Type +	Ma	Location *	WS
Category	Earthen Levee			GPS Latitude/Longitude	
				Start	End
Item	Animal Control			37.045485 °	37.060091 °
				-120.427423 °	-120.405340 °
DWR ID	DWR_NA0011_02_f_2015_39				
Comment Code					
A1 : Exterminate rodents and backfill and compact or grout burrows.					
Inspector Comment					
The levee section waterside is covered with rodents and rodent holes. There is no bait stations on this levee section and the weeds here are too tall to see the active rodents. No new photo was taken.

Active rodents spotted in the area waterside slope levee mile 0.00- 1.67.

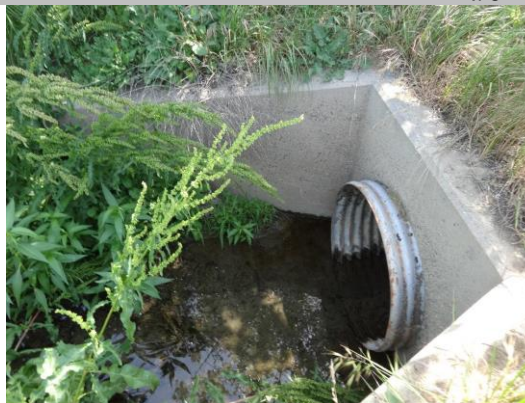
Photo 3 of 3 : UCIP_SP_2017_39686_71660.jpg

LM Start	0.01	Rating **	M	Issue No.	47 (cont)	
LM End	0.01	Issue Type +	En	Location *	WS	
Category	Supplemental			GPS Latitude/Longitude		
				Start	End	
Item	DWR UCIP Field Study			37.045532 °	37.045532 °	
				-120.427268 °	-120.427268 °	
DWR ID						
Comment Code						
Inspector Comment						
FS_ID:39686						
DS_ID:21585						
EP_NO: 8068						
Repair Type: Non-Urgent						
Crossing Status: Found						
UCIP Comments: Unable to confirm if crossing found in the field corresponds to the crossing described under Permit 8068. Only 1 crossing found permit indicates 2 irrigation culverst. Need to contact owner to obtain additional details of crossing.						
FIELD_STRUCT_DESC: To retain two irrigation culverts and siphons located at the intersection of Ash Slough and the Chowchilla Canal.						
FS Date: 5/6/2014

Pipe outlet on waterward side.

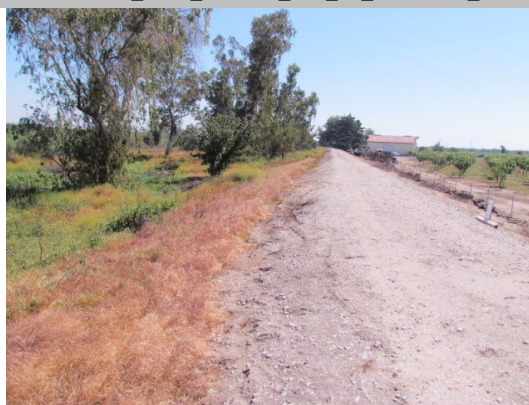
Photo 1 of 1 : SP_2017_NA0011_143_13_20170508_00037.jpg

LM Start	0.03	Rating **	U	Issue No.	13
LM End	2.00	Issue Type +	Ma	Location *	WS
Category	Earthen Levee			GPS Latitude/Longitude	
				Start	End
Item	Vegetation			37.045623 °	37.063718 °
				-120.426988 °	-120.401358 °
DWR ID	DWR_NA0011_02_s _ 2017_13				
Comment Code					
V1 : Control annual grass and weeds on the levee slopes and easements.					
Inspector Comment					
Remove the unwanted vegetation from the waterside levee slope.

Looking upstream from the waterside slope levee mile 0.03.

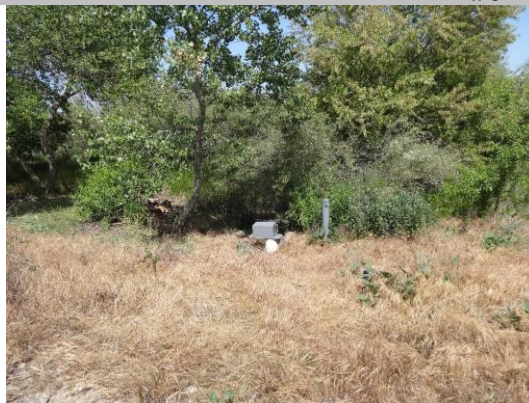
Photo 1 of 3 : UCIP_SP_2017_35764_64463.jpg

Comment Code					
Inspector Comment					
FS_ID:35764 DS_ID:21514 EP_NO: N/A Repair Type: Non-Urgent Crossing Status: Found UCIP Comments: Need to contact owner to determine details of crossing and permit information authorizing crossing. Dense vegetation limits the inspector's visibility to identify signs of pipe failure (leaks) along the slope. Recommend removing vegetation along pipe alignment to conduct proper inspection of structure and appurtenances. FIELD_STRUCT_DESC: Pipe through levee at a skew. Concrete discharge structure at waterward end. Standpipe with gage house landward of the levee. No gage house found on landward side. FS Date: 5/6/2014

View of waterward side.

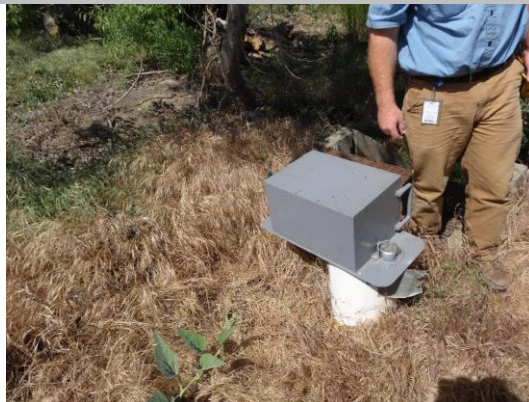
Photo 2 of 3 : UCIP_SP_2017_35764_64466.jpg

LM Start	0.31	Rating **	M	Issue No.	48 (cont)
LM End	0.31	Issue Type +	En	Location *	WS

Locked box (unknown purpose) located on waterward side.

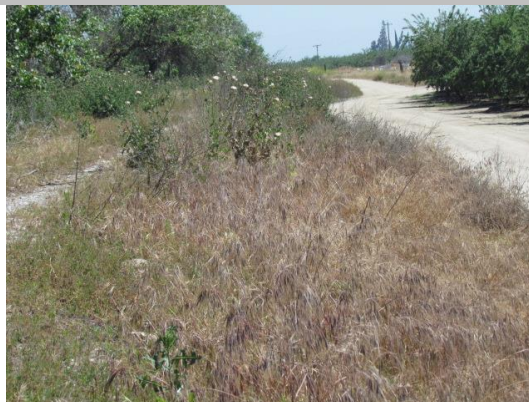
Photo 1 of 1 : SP_2017_NA0011_143_30_20170508_00041.jpg

LM Start	0.32	Rating **	U	Issue No.	30
LM End	0.97	Issue Type +	Ma	Location *	LS
Category	Earthen Levee			GPS Latitude/Longitude	
				Start	End
Item	Vegetation			37.047387 °	37.054878 °
				-120.422183 °	-120.415525 °
DWR ID	DWR_NA0011_02_s_2017_30				
Comment Code					
V2 : Remove the wild growth other than native grasses from the levee slopes.					
Inspector Comment					
Spray or mow the wild weeds on the waterside levee slope.

Unwanted vegetation on the waterside levee slope.

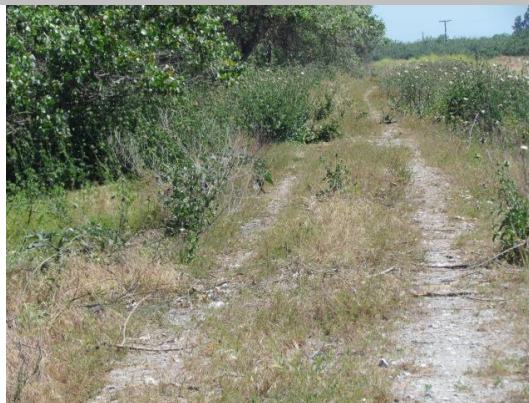
Photo 1 of 1 : SP_2017_NA0011_143_31_20170508_00042.jpg

LM Start	0.32	Rating **	U	Issue No.	31
LM End	2.02	Issue Type +	Ma	Location *	CR
Category	Earthen Levee			GPS Latitude/Longitude	
				Start	End
Item	Vegetation			37.047387 °	37.063896 °
				-120.422183 °	-120.401230 °
DWR ID	DWR_NA0011_02_s_2017_31				
Comment Code					
V9 : Keep the crown roadway free of vegetation.					
Inspector Comment					
Keep crown roadway free of vegetation.

Looking upstream levee mile 0.32-0.97 wild growth present on the crown roadway.

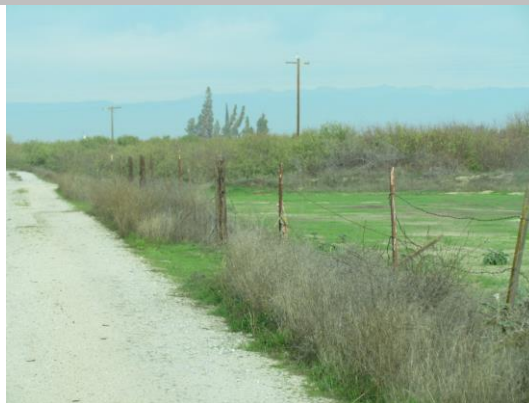
Photo 1 of 1 : SP_2017_NA0011_143_11_20170404_00006.jpg

LM Start	0.45	Rating **	M	Issue No.	11
LM End	0.53	Issue Type +	En	Location *	LS
Category	Earthen Levee			GPS Latitude/Longitude	
				Start	End
Item	Encroachments			37.048627 °	37.049342 °
				-120.420357 °	-120.419370 °
DWR ID	DWR_NA0011_02_s_2012_11				
Comment Code					
FE : Fence					
Inspector Comment					
Wire fence on the landside levee shoulder along with unwanted tall weed growth..

Fence on the landside slope.

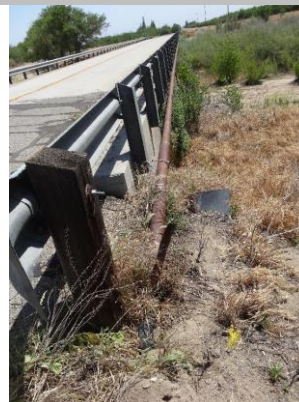
Photo 2 of 3 : UCIP_SP_2017_39923_71822.jpg

LM Start	0.94	Rating **	M	Issue No.	49 (cont)
LM End	0.94	Issue Type +	En	Location *	WS

View of steel conduit through levee and above channel.

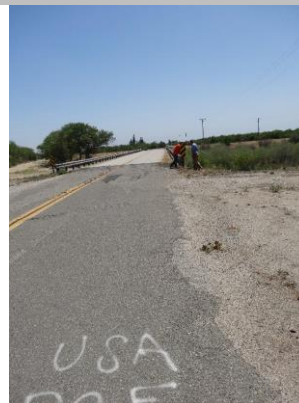
Photo 3 of 3 : UCIP_SP_2017_39923_71821.jpg

LM Start	0.94	Rating **	M	Issue No.	49 (cont)
LM End	0.94	Issue Type +	En	Location *	WS
Category	Supplemental			GPS Latitude/Longitude	
				Start	End
Item	DWR UCIP Field Study			37.054547 °	37.054547 °
				-120.415826 °	-120.415826 °
DWR ID					
Comment Code					
Inspector Comment					
FS_ID:39923 DS_ID:25043 EP_NO: N/A Repair Type: Non-Urgent Crossing Status: Found UCIP Comments: Need to contact owner to determine status. Need permit authorizing work. FIELD_STRUCT_DESC: 5-inch steel conduit along bridge downstream face. Upstream face has 2-inch pipe cut at the corner. FS Date: 5/6/2014

Overview of bridge.

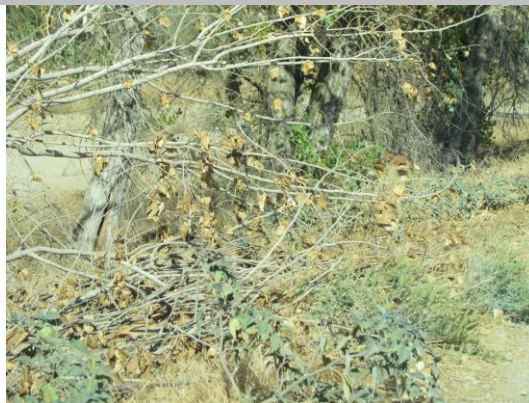
Photo 1 of 2 : SP_2017_NA0011_143_27_20170404_00013.jpg

LM Start	0.98	Rating **	U	Issue No.	27
LM End	1.52	Issue Type +	En	Location *	WS
Category	Earthen Levee			GPS Latitude/Longitude	
				Start	End
Item	Encroachments			37.054928 °	37.058752 °
				-120.415482 °	-120.407323 °
DWR ID	DWR_NA0011_02_s_2017_27				
Comment Code					
TR : Tree or limb					
Inspector Comment					
Remove the dead trees from the waterside slope and shoulder.

Levee slope and shoulder looking upstream waterside levee section.

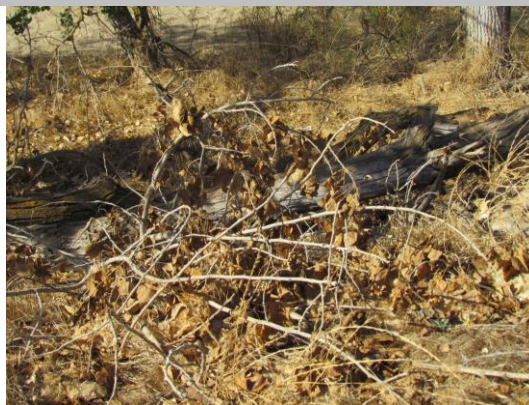
Photo 2 of 2 : SP_2017_NA0011_143_27_20170404_00014.jpg

LM Start	0.98	Rating **	U	Issue No.	27 (cont)
LM End	1.52	Issue Type +	En	Location *	WS

Unit 2 Ash Slough Levee mile 0.98 waterside shoulder and slope

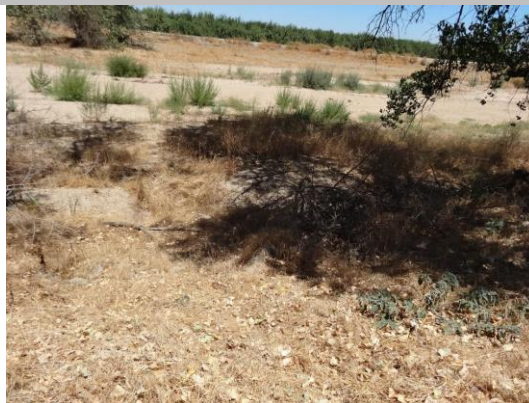
Photo 1 of 3 : SP_2017_NA0011_143_1_20170404_00001.jpg

LM Start	1.10	Rating **	U	Issue No.	1 (cont)
LM End	1.19	Issue Type +	Ma	Location *	WS

View of the erosion site from the levee crest.

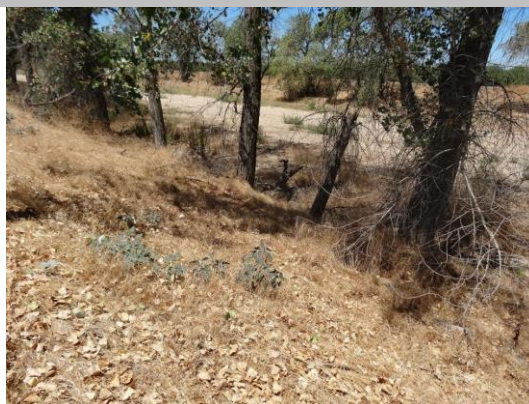
Photo 2 of 3 : SP_2017_NA0011_143_1_20170404_00002.jpg

Close view of the site.

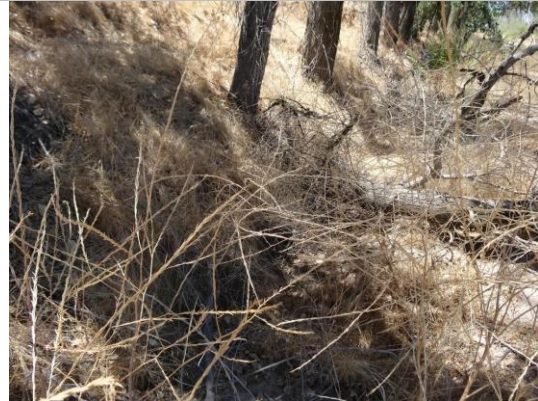
Photo 3 of 3 : SP_2017_NA0011_143_1_20170404_00003.jpg

Comment Code						
Inspector Comment						
07/22/2016: No significant change observed.						
09/08/2015: No significant change observed.						
07/22/2014: No significant change observed.						
08/30/2013: No significant change observed.						
07/31/2012: Site was visited on 07/24/2012. No significant change observed. Dense vegetation around the site						
08/09/2011: Site was inspected. No visible change was observed from the previous condition. A fallen tree was seen at the levee toe about 20 feet upstream, and tree root exposed. There has been no report from the district that this site was corrected.						
11/30/2010: Site was not inspected due to time constraints. There have been no reports from the district that the site was corrected. Continue to monitor site during flood events.						
08/05/2010: Recommended for annual assessment and monitoring during flood events, per CLRO.						
2009: Site is recommended as a local maintenance issue, per Critical Levee Repair Office, Critical Erosion Sites Evaluation 2008 Report; site was previously rated "M"

9/6/2007: Undercutting of the toe; several trees along the WS slope with roots exposed. [2016 Site ID:NA0011U02RM2.57]

Close view of the site.

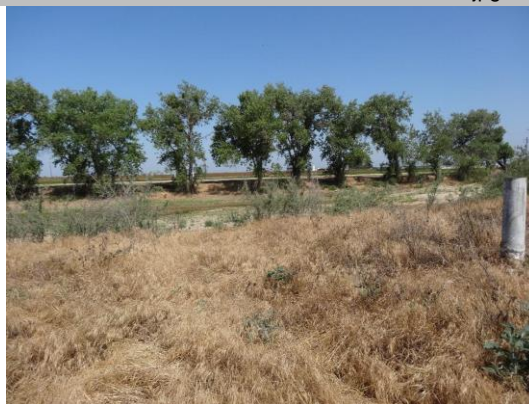
Photo 3 of 3 : UCIP_SP_2017_39925_71819.jpg

LM Start	2.02	Rating **	M	Issue No.	51 (cont)	
LM End	2.02	Issue Type +	En	Location *	LS	
Category	Supplemental			GPS Latitude/Longitude		
				Start		End
Item	DWR UCIP Field Study			37.063982 °		37.063982 °
				-120.401165 °		-120.401165 °
DWR ID						
Comment Code						
Inspector Comment						
FS_ID:39925 DS_ID:25045 EP_NO: N/A Repair Type: Non-Urgent Crossing Status: Indicator Found UCIP Comments: Need to contact owner to determine additional information about crossing and potential appurtenances. FIELD_STRUCT_DESC: 36-inch filled with concrete. FS Date: 5/6/2014

36-inch pipe full of concrete debris located on waterward side.

View of waterward side.

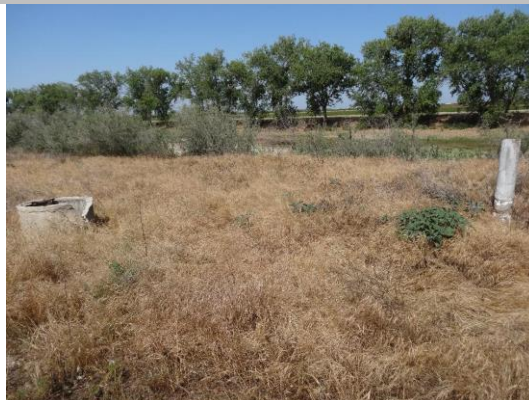
Photo 2 of 3 : UCIP_SP_2017_39924_71808.jpg

LM Start	2.03	Rating **	M	Issue No.	52 (cont)
LM End	2.03	Issue Type +	En	Location *	LS

Concrete standpipes visible on waterward side--dense vegetation on waterward side.

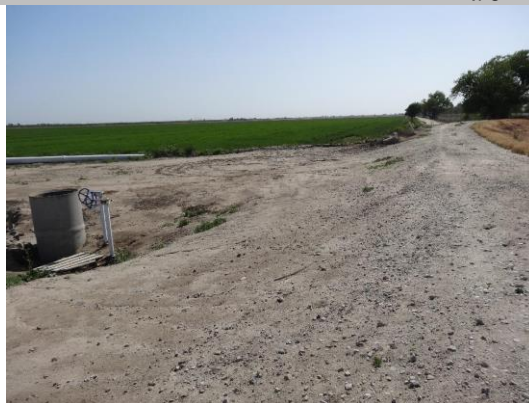
Photo 1 of 3 : UCIP_SP_2017_35767_64476.jpg

LM Start	0.00	Rating **	M	Issue No.	46
LM End	0.00	Issue Type +	En	Location *	WS
Category	Supplemental			GPS Latitude/Longitude	
				Start	End
Item	DWR UCIP Field Study			36.996593 °	36.996593 °
				-120.373636 °	-120.373636 °
DWR ID					
Comment Code					
Inspector Comment					
FS_ID:35767					
DS_ID:21516					
EP_NO: N/A					
Repair Type: Non-Urgent					
Crossing Status: Found					
UCIP Comments: Unable to confirm if crossing is still being used. Need to contact owner to determine status of crossing.					
FIELD_STRUCT_DESC: 18-inch steel pipe through levee at unknown depth. Levee log records indicate the abandonment of the Chowchilla Canal Siphon was backfilled through the levee section. Pipe through levee slant pump on waterward slope.					
FS Date: 5/6/2014

View of landward side.

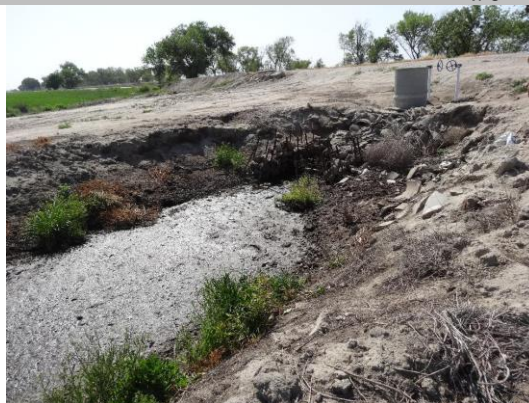
Photo 3 of 3 : UCIP_SP_2017_35767_64474.jpg

LM Start	0.00	Rating **	M	Issue No.	46 (cont)	
LM End	0.00	Issue Type +	En	Location *	WS	
Category	Supplemental			GPS Latitude/Longitude		
				Start		End
Item	DWR UCIP Field Study			36.996593 °		36.996593 °
				-120.373636 °		-120.373636 °
DWR ID						
Comment Code						
Inspector Comment						
FS_ID:35767						
DS_ID:21516						
EP_NO: N/A						
Repair Type: Non-Urgent						
Crossing Status: Found						
UCIP Comments: Unable to confirm if crossing is still being used. Need to contact owner to determine status of crossing.						
FIELD_STRUCT_DESC: 18-inch steel pipe through levee at unknown depth. Levee log records indicate the abandonment of the Chowchilla Canal Siphon was backfilled through the levee section. Pipe through levee slant pump on waterward slope.						
FS Date: 5/6/2014

Canal located on landward side.

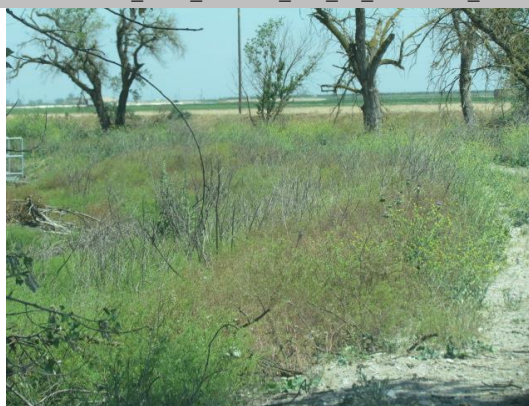
Photo 1 of 1 : SP_2017_NA0011_144_10_20170509_00018.jpg

LM Start	0.05	Rating **	U	Issue No.	10
LM End	1.51	Issue Type +	Ma	Location *	LS
Category	Earthen Levee			GPS Latitude/Longitude	
				Start	End
Item	Vegetation			36.996442 °	36.996613 °
				-120.372907 °	-120.346565 °
DWR ID	DWR_NA0011_03_s_2017_10				
Comment Code					
V1 : Control annual grass and weeds on the levee slopes and easements.					
Inspector Comment					
Remove the wild growth of weeds from the landside levee section.

Looking upstream from the landside shoulder from levee mile 0.05 unwanted tall weeds completely blocks view of the landward levee section.

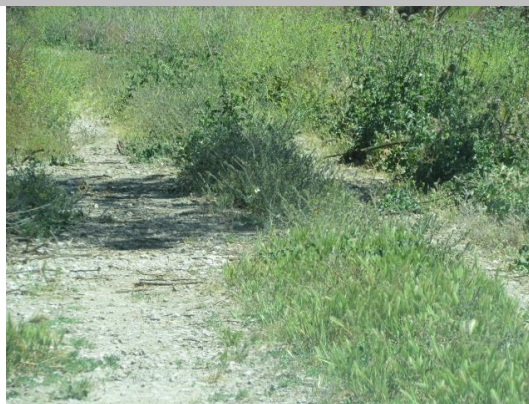
Photo 1 of 1 : SP_2017_NA0011_144_12_20170509_00017.jpg

LM Start	0.05	Rating **	U	Issue No.	12
LM End	1.51	Issue Type +	Ma	Location *	CR
Category	Earthen Levee			GPS Latitude/Longitude	
				Start	End
Item	Vegetation			36.996442 °	36.996613 °
				-120.372907 °	-120.346565 °
DWR ID	DWR_NA0011_03_s_2017_12				
Comment Code					
V9 : Keep the crown roadway free of vegetation.					
Inspector Comment					
Keep the crown roadway free of all vegetation.

Looking upstream at the crown roadway that's covered with wild vegetation.

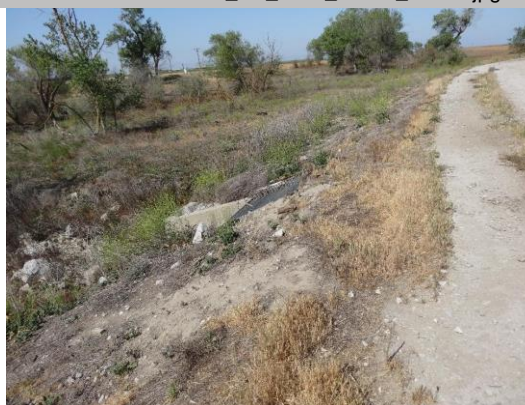
Photo 1 of 3 : UCIP_SP_2017_38228_69689.jpg

LM Start	0.10	Rating **	M	Issue No.	47
LM End	0.10	Issue Type +	En	Location *	LS
Category	Supplemental			GPS Latitude/Longitude	
				Start	End
Item	DWR UCIP Field Study			36.996177 °	36.996177 °
				-120.371967 °	-120.371967 °
DWR ID					
Comment Code					
Inspector Comment					
FS_ID:38228 DS_ID:21517 EP_NO: N/A Repair Type: Non-Urgent Crossing Status: Found UCIP Comments: Need to contact owner to determine status of crossing. Unable to determine if crossing is in use. FIELD_STRUCT_DESC: 36-inch CM pipe through the levee, 7.3 feet below the crown. Headwalls and wing walls on both ends. Flap gate on waterward end. FS Date: 5/6/2014

View of waterward side.

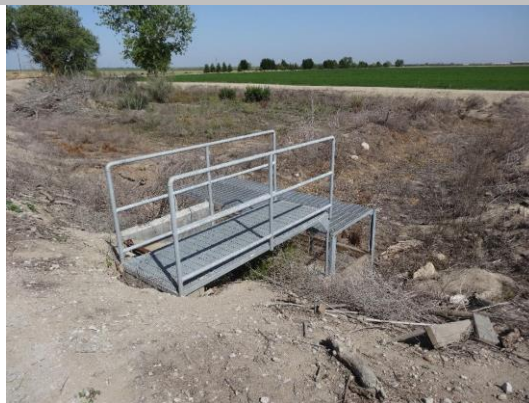
Photo 3 of 3 : UCIP_SP_2017_38228_69688.jpg

LM Start	0.10	Rating **	M	Issue No.	47 (cont)
LM End	0.10	Issue Type +	En	Location *	LS

View of landward side.

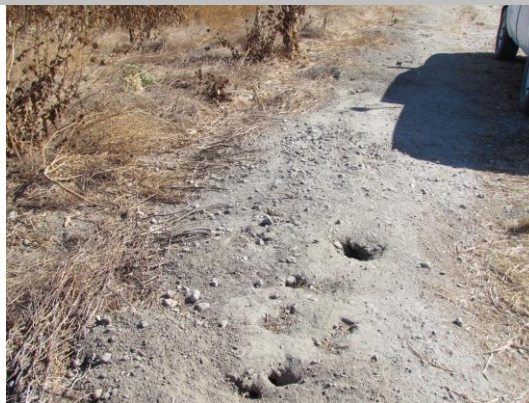
Photo 1 of 2 : SP_2017_NA0011_144_6_20170404_00004.jpg

LM Start	0.40	Rating **	U	Issue No.	6
LM End	1.51	Issue Type +	Ma	Location *	LS
Category	Earthen Levee			GPS Latitude/Longitude	
				Start	End
Item	Animal Control			36.996208 °	36.996607 °
				-120.366550 °	-120.346568 °
DWR ID	DWR_NA0011_03_f_2016_6				
Comment Code					
A1 : Exterminate rodents and backfill and compact or grout burrows.					
Inspector Comment					
There need to be rodent bait stations placed along the landside slope and or shoulder at levee miles listed. No new photo was taken. Unable to see the ground, observed rodents running across the roadway.

Berenda Slough Unit 3 levee miles 0.40-1.51 landside shoulder and slope.

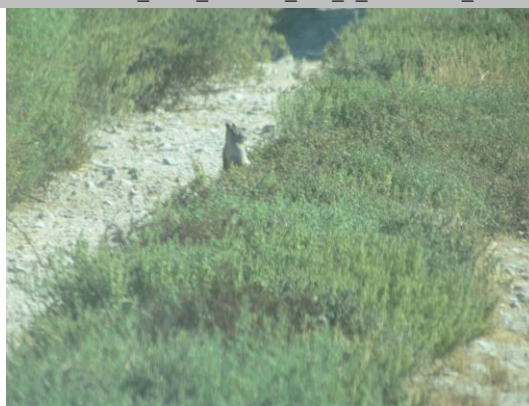
Photo 1 of 1 : SP_2017_NA0011_144_8_20170404_00006.jpg

LM Start	0.71	Rating **	M	Issue No.	8
LM End	1.51	Issue Type +	Ma	Location *	CR
Category	Earthen Levee			GPS Latitude/Longitude	
				Start	End
Item	Animal Control			36.996257 °	36.996607 °
				-120.361025 °	-120.346568 °
DWR ID	DWR_NA0011_03_f_2016_8				
Comment Code					
A1 : Exterminate rodents and backfill and compact or grout burrows.					
Inspector Comment					
Exterminate rodents from the crown roadway in the area listed. Active rodents observed during inspection at this site.

Berenda Slough Unit 3 looking upstream from levee miles 0.71 - to 1.51.

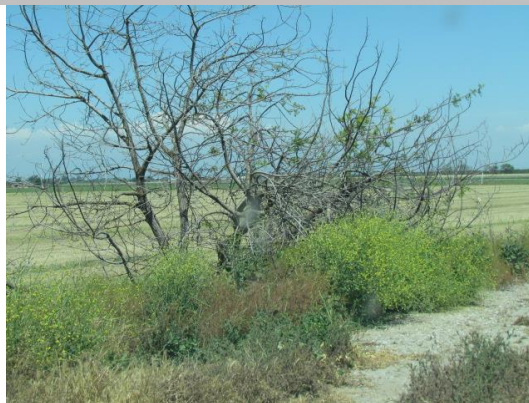
Photo 2 of 2 : SP_2017_NA0011_144_11_20170509_00020.jpg

LM Start	1.04	Rating **	U	Issue No.	11 (cont)	
LM End	1.05	Issue Type +	Ma	Location *	LS	
Category	Earthen Levee			GPS Latitude/Longitude		
				Start		End
Item	Trim / Thin Trees			36.996613 °		36.996610 °
				-120.355055 °		-120.354995 °
DWR ID	DWR_NA0011_03_s_2012_11					
Comment Code						
T1 : Trim trees to at least five feet above ground level.						
Inspector Comment						
Take these walnuts off the levee section.

levee mile 1.04-1.05 landside slope and shoulder wild walnut tree growth was covered with leaves that blocked the view of the levee section.

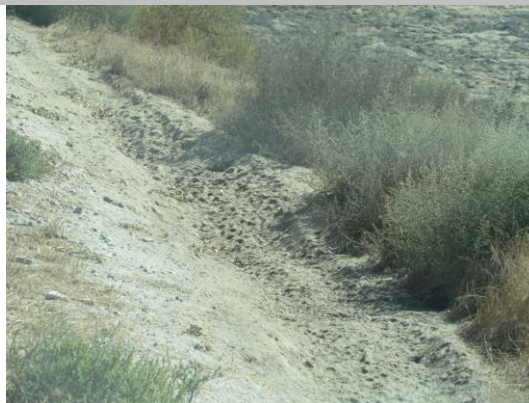
Photo 1 of 1 : SP_2017_NA0011_144_4_20170404_00002.jpg

LM Start	1.24	Rating **	U	Issue No.	4
LM End	1.25	Issue Type +	Ma	Location *	CR
Category	Earthen Levee			GPS Latitude/Longitude	
				Start	End
Item	Slope Stability			36.996582 °	36.996582 °
				-120.351482 °	-120.351258 °
DWR ID	DWR_NA0011_03_f_2016_4				
Comment Code					
S1 : Repair slope instability.					
Inspector Comment					
Repair the slope instability and damaged shoulder at this location. The cause for this damage is the walnut trees landside encroaching onto the levee crown forcing the traffic to vere around.

Berenda Slough looking back upstream waterside at the shoulder and slope levee miles 1.24-1.25.

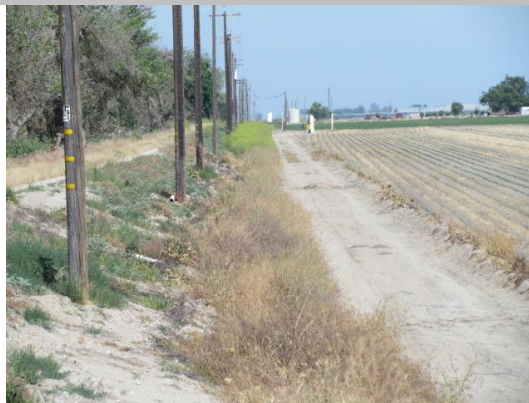
Photo 1 of 1 : SP_2017_NA0011_145_6_20170510_00019.jpg

LM Start	0.01	Rating **	U	Issue No.	6
LM End	1.50	Issue Type +	Ma	Location *	LS
Category	Earthen Levee			GPS Latitude/Longitude	
				Start	End
Item	Vegetation			36.995503 °	36.995583 °
				-120.373417 °	-120.346448 °
DWR ID	DWR_NA0011_04_s_2017_6				
Comment Code					
V1 : Control annual grass and weeds on the levee slopes and easements.					
Inspector Comment

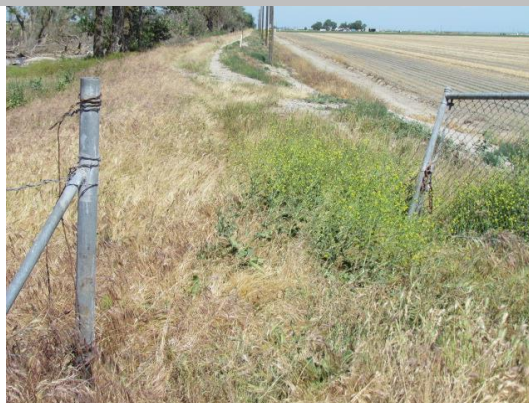
Photo 1 of 1 : SP_2017_NA0011_145_7_20170510_00018.jpg

LM Start	0.01	Rating **	U	Issue No.	7
LM End	1.50	Issue Type +	Ma	Location *	WS
Category	Earthen Levee			GPS Latitude/Longitude	
				Start	End
Item	Vegetation			36.995503 °	36.995583 °
				-120.373417 °	-120.346448 °
DWR ID	DWR_NA0011_04_s_2017_7				
Comment Code					
V1 : Control annual grass and weeds on the levee slopes and easements.					
Inspector Comment					
No maintenance has been done to this levee section in several years now. The tall weeds makes it hard to inspect.

Looking upstream from levee mile 0.01 at waterside slope tall unwanted vegetation on the levee section.

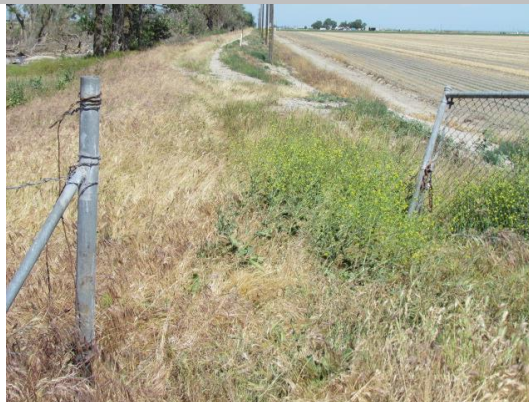
Photo 1 of 1 : SP_2017_NA0011_145_8_20170511_00020.jpg

LM Start	0.01	Rating **	U	Issue No.	8
LM End	1.50	Issue Type +	Ma	Location *	CR
Category	Earthen Levee			GPS Latitude/Longitude	
				Start	End
Item	Vegetation			36.995503 °	36.995613 °
				-120.373417 °	-120.346358 °
DWR ID	DWR_NA0011_04_s_2017_8				
Comment Code					
V9 : Keep the crown roadway free of vegetation.					
Inspector Comment					
Keep the crown roadway free of vegetation.

Looking upstream from levee mile 0.01 at the wild vegetation growing on the crown roadway.

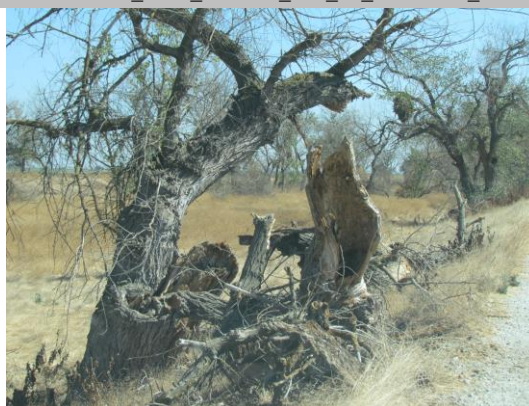
Photo 1 of 1 : SP_2017_NA0011_145_15_20170404_00008.jpg

LM Start	0.14	Rating **	U	Issue No.	15
LM End	0.14	Issue Type +	Ma	Location *	CR
Category	Earthen Levee			GPS Latitude/Longitude	
				Start	End
Item	Encroachments			36.995528 °	36.995528 °
				-120.370922 °	-120.370922 °
DWR ID	DWR_NA0011_04_f_2015_15				
Comment Code					
TR : Tree or limb					
Inspector Comment					
There are many dead trees in the area. This one happened to be blocking the crown roadway. Remove the dead trees from the levee section. Many more are subject to fall and further block access to the levee crown.

Berenda Slough looking upstream from the levee mile 0.14.

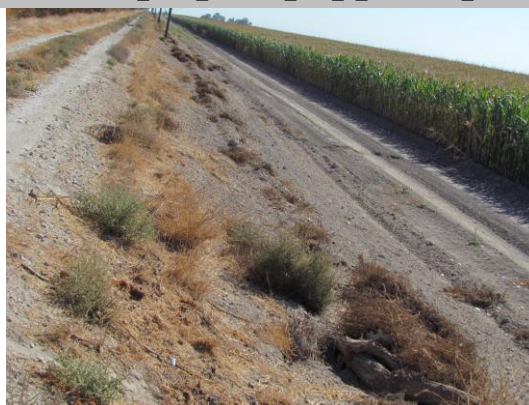
Photo 1 of 1 : SP_2017_NA0011_145_3_20170404_00002.jpg

LM Start	0.14	Rating **	U	Issue No.	3
LM End	0.97	Issue Type +	Ma	Location *	LS
Category	Earthen Levee			GPS Latitude/Longitude	
				Start	End
Item	Slope Stability			36.995543 °	36.995550 °
				-120.370907 °	-120.355935 °
DWR ID	DWR_NA0011_04_f_2016_3				
Comment Code					
S1 : Repair slope instability.					
Inspector Comment					
The slope in this area has been damaged by farm equipment on the slope.

Berenda Slough Unit 4 Looking upstream from levee mile 0.14-0.97.

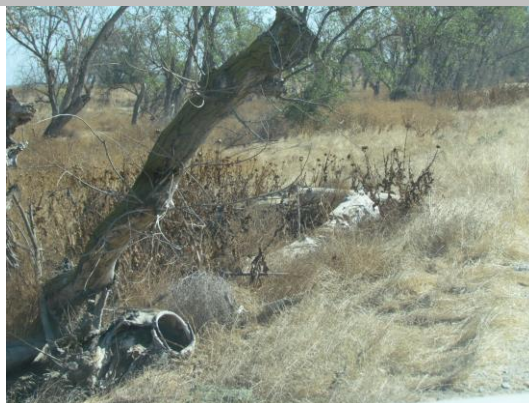
Photo 1 of 1 : SP_2017_NA0011_145_16_20170404_00009.jpg

LM Start	0.47	Rating **	U	Issue No.	16
LM End	0.47	Issue Type +	Ma	Location *	WS
Category	Earthen Levee			GPS Latitude/Longitude	
				Start	End
Item	Encroachments			36.995603 °	36.995603 °
				-120.364978 °	-120.364978 °
DWR ID	DWR_NA0011_04_s_2014_16				
Comment Code					
TR : Tree or limb					
Inspector Comment					
This dead tree on water ward slope should be removed from levee section. No change. 2017

Berenda Slough Unit 4 levee mile 0.47 looking back upstream.

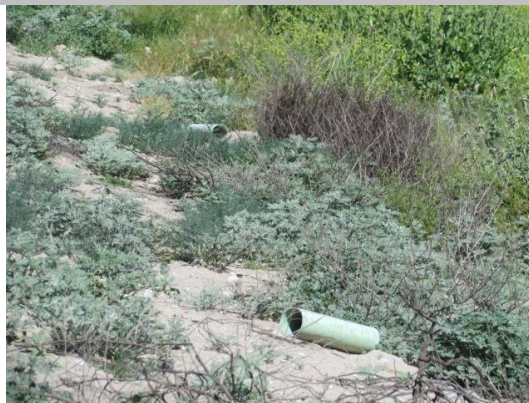
Photo 1 of 3 : SP_2017_NA0011_145_11_20170511_00021.jpg

LM Start	0.62	Rating **	U	Issue No.	11
LM End	2.09	Issue Type +	Ma	Location *	LS
Category	Earthen Levee			GPS Latitude/Longitude	
				Start	End
Item	Animal Control			36.995568 °	37.001737 °
				-120.362303 °	-120.339150 °
DWR ID	DWR_NA0011_04_f_2016_11				
Comment Code					
A1 : Exterminate rodents and backfill and compact or grout burrows.					
Inspector Comment					
Exterminate the rodents and backfill and compact or grout the burrows in this area listed.

Berenda Slough looking upstream levee mile 0.62 landward.

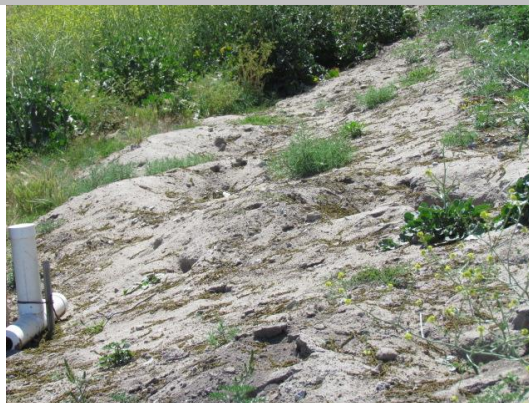
Photo 2 of 3 : SP_2017_NA0011_145_11_20170511_00022.jpg

LM Start	0.62	Rating **	U	Issue No.	11 (cont)	
LM End	2.09	Issue Type +	Ma	Location *	LS	
Category	Earthen Levee			GPS Latitude/Longitude		
				Start		End
Item	Animal Control			36.995568 °		37.001737 °
				-120.362303 °		-120.339150 °
DWR ID	DWR_NA0011_04_f_2016_11					
Comment Code						
A1 : Exterminate rodents and backfill and compact or grout burrows.						
Inspector Comment						
Exterminate the rodents and backfill and compact or grout the burrows in this area listed.

Berenda Slough looking downstream levee 0.62 landside slope covered with rodent holes to levee mile 2.09.

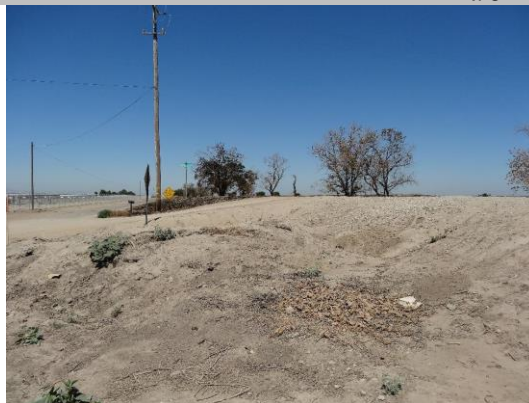
Photo 1 of 3 : UCIP_SP_2017_49977_75760.jpg

LM Start	1.50	Rating **	U	Issue No.	60
LM End	1.50	Issue Type +	En	Location *	LS
Category	Supplemental			GPS Latitude/Longitude	
				Start	End
Item	DWR UCIP Field Study			36.995597 °	36.995597 °
				-120.346418 °	-120.346418 °
DWR ID					
Comment Code					
Inspector Comment					
FS_ID:49977 DS_ID:25469 EP_NO: N/A Repair Type: Urgent Crossing Status: Found UCIP Comments: 7/14/2016 New entry added--pipe failure. Sink hole present on LS slope. Concrete headwall collapse visible on LS slope. Pipe buried on both WS and LS. (DWR UCIP - omagana) FIELD_STRUCT_DESC: Unknown size drainage pipe through the levee, approximately 5 feet below the crown. Concrete headwall located on the landside (LS). Corrugated metal pipe located on LS toe. Sluice gate is located on the waterside (WS). FS Date: 7/14/2016

View of LS slope.

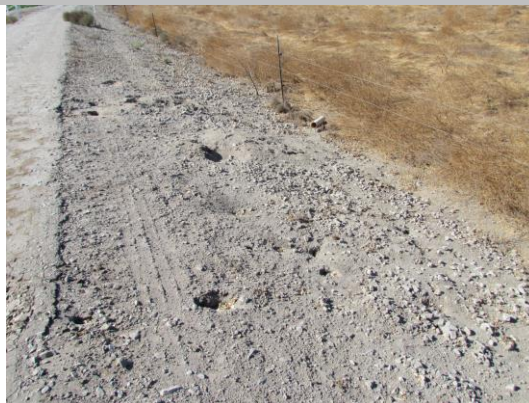
Photo 1 of 1 : SP_2017_NA0011_145_30_20170404_00010.jpg

LM Start	1.63	Rating **	U	Issue No.	30
LM End	2.23	Issue Type +	Ma	Location *	WS
Category	Earthen Levee			GPS Latitude/Longitude	
				Start	End
Item	Animal Control			36.996503 °	37.003308 °
				-120.344465 °	-120.337550 °
DWR ID	DWR_NA0011_04_f_2014_30				
Comment Code					
A1 : Exterminate rodents and backfill and compact or grout burrows.					
Inspector Comment					
Bait stations are needed in Rodent infested area waterside slope and toe. No new photo.

Berenda Slough levee mile 1.63-2.23 looking upstream at waterside slope.

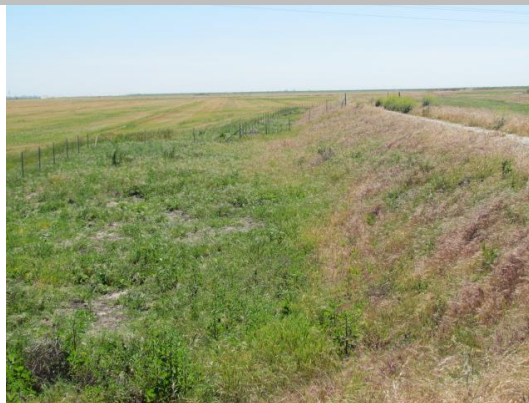
Photo 1 of 1 : SP_2017_NA0011_146_7_20170518_00020.jpg

LM Start	0.00	Rating **	U	Issue No.	7
LM End	4.05	Issue Type +	Ma	Location *	LS
Category	Earthen Levee			GPS Latitude/Longitude	
				Start	End
Item	Vegetation			36.978520 °	36.968168 °
				-120.368567 °	-120.301035 °
DWR ID	DWR_NA0011_05_f_2016_7				
Comment Code					
V2 : Remove the wild growth other than native grasses from the levee slopes.					
Inspector Comment					
Remove all tall dead weeds from the landside slope and shoulder from levee mile 0.00 -4.05.

Looking upstream from levee mile 0.00 landside slope unwanted tall weeds block view of levee slope.

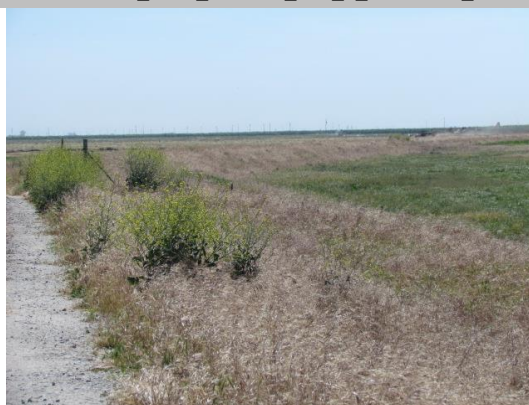
Photo 1 of 1 : SP_2017_NA0011_146_9_20170518_00021.jpg

LM Start	0.00	Rating **	U	Issue No.	9	
LM End	4.05	Issue Type +	Ma	Location *	WS	
Category	Earthen Levee			GPS Latitude/Longitude		
				Start	End	
Item	Vegetation			36.978520 °	36.968168 °	
				-120.368567 °	-120.301035 °	
DWR ID	DWR_NA0011_05_f_2016_9					
Comment Code						
V1 : Control annual grass and weeds on the levee slopes and easements.						
Inspector Comment						
Remove the tall dead weeds from the levee section listed.

Fresno River looking upstream waterside levee mile 0.00.

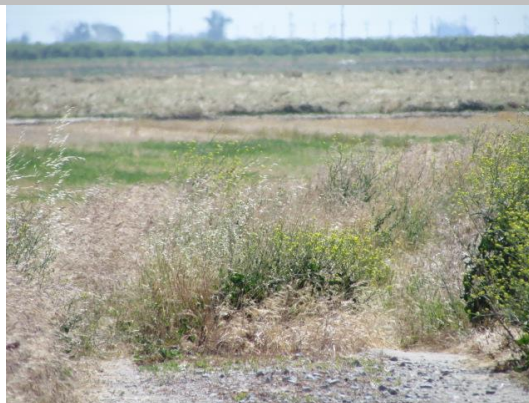
Photo 1 of 1 : SP_2017_NA0011_146_8_20170518_00022.jpg

LM Start	0.00	Rating **	U	Issue No.	8
LM End	4.05	Issue Type +	Ma	Location *	CR
Category	Earthen Levee			GPS Latitude/Longitude	
				Start	End
Item	Vegetation			36.978557 °	36.968152 °
				-120.368423 °	-120.301103 °
DWR ID	DWR_NA0011_05_f_2015_8				
Comment Code					
V9 : Keep the crown roadway free of vegetation.					
Inspector Comment					
The crown roadway must be free of all vegetation. Tall weeds blocking view of crown roadway.

Fresno River looking upstream levee mile 0.00.

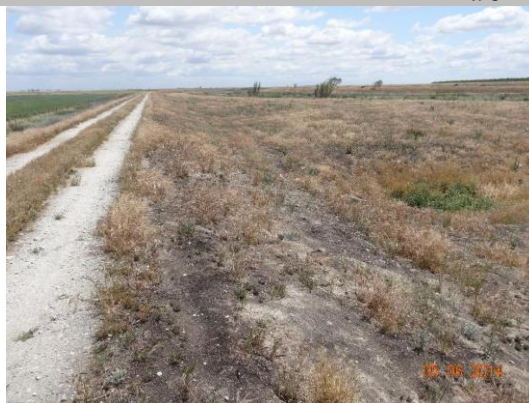
Photo 1 of 3 : UCIP_SP_2017_35795_64567.jpg

LM Start	0.18	Rating **	M	Issue No.	36
LM End	0.18	Issue Type +	En	Location *	CR
Category	Supplemental			GPS Latitude/Longitude	
				Start	End
Item	DWR UCIP Field Study			36.978036 °	36.978036 °
				-120.365246 °	-120.365246 °
DWR ID					
Comment Code					
Inspector Comment					
FS_ID:35795 DS_ID:21520 EP_NO: N/A Repair Type: Non-Urgent Crossing Status: Found UCIP Comments: Need to contact owner. Dense vegetation limits the inspector's visibility to identify signs of pipe failure (leaks) along the landward slope. Recommend removing vegetation along pipe alignment to conduct proper inspection of structure. FIELD_STRUCT_DESC: 36-inch CM pipe through the levee, 10.8 feet below the crown. Headwalls and wing walls on both ends. Flap gate on waterward end. FS Date: 5/6/2014

View of waterward side.

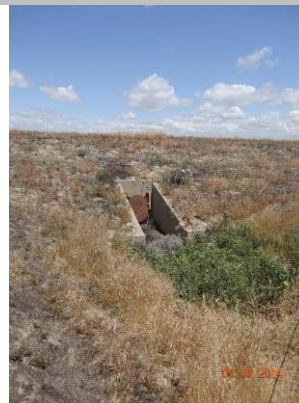
Photo 2 of 3 : UCIP_SP_2017_35795_64566.jpg

LM Start	0.18	Rating **	M	Issue No.	36 (cont)	
LM End	0.18	Issue Type +	En	Location *	CR	
Category	Supplemental			GPS Latitude/Longitude		
				Start		End
Item	DWR UCIP Field Study			36.978036 °		36.978036 °
				-120.365246 °		-120.365246 °
DWR ID						
Comment Code						
Inspector Comment						
FS_ID:35795						
DS_ID:21520						
EP_NO: N/A						
Repair Type: Non-Urgent						
Crossing Status: Found						
UCIP Comments: Need to contact owner. Dense vegetation limits the inspector's visibility to identify signs of pipe failure (leaks) along the landward slope. Recommend removing vegetation along pipe alignment to conduct proper inspection of structure.						
FIELD_STRUCT_DESC: 36-inch CM pipe through the levee, 10.8 feet below the crown. Headwalls and wing walls on both ends. Flap gate on waterward end.						
FS Date: 5/6/2014

View of flap gate and concrete headwall located on waterward side.

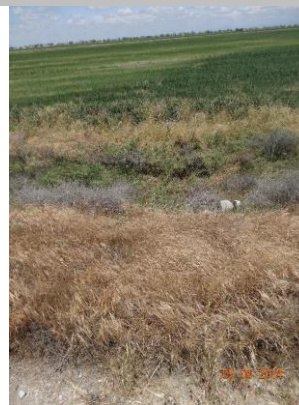
Photo 3 of 3 : UCIP_SP_2017_35795_64565.jpg

View of landward side.

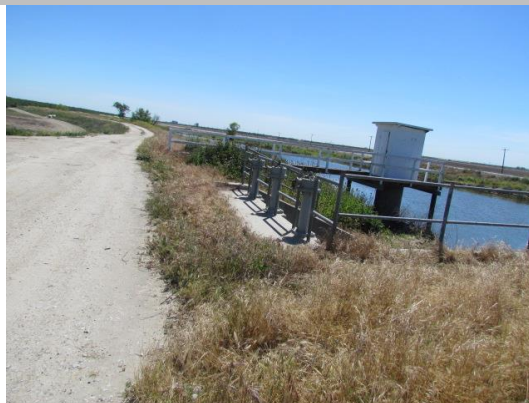
Photo 1 of 1 : SP_2017_NA0011_146_17_20170518_00023.jpg

LM Start	6.57	Rating **	U	Issue No.	17
LM End	9.10	Issue Type +	Ma	Location *	WS
Category	Earthen Levee			GPS Latitude/Longitude	
				Start	End
Item	Vegetation			36.968502 °	36.973318 °
				-120.255603 °	-120.211600 °
DWR ID	DWR_NA0011_05_s_2017_17				
Comment Code					
V2 : Remove the wild growth other than native grasses from the levee slopes.					
Inspector Comment					
Remove the wild growth other than native grasses.

Fresno River waterside looking upstream from levee mile 6.57, wild weed growth present on slope and shoulder.
